MONITORING OF SELECTED GEOHAZARDS BY USING UNMANNED AERIAL SYSTEMS (UAS)

Key words: Unmanned aircraft systems, Photogrammetry, Mapping, Digital terrain model, Landslide

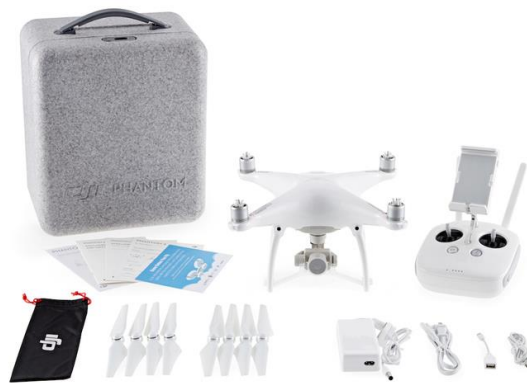
Fig. 4. UAV - DJI Phantom 4.
Source: Own study.

The data collection was performed using the DJI Phantom 4 quadcopter (Fig. 4). This UAS device belongs to the category of "cheap" UAVs. It contains as well a built-in GPS module, a gyrocompass and a 12Mpx DJI HD camera. The camera is mounted on a 3-axis gimbal. The whole flight was pre-programmed by the Android application Pix4D. Three flights in different heights were realized in total. Each took about 15 minutes. A total of 363 aerial images were created. Specifications of the UAS are stated in Table. 1

Table 1. DJI Phantom 4 – technical parameters.

Aircraft	
Weight (Battery & Propellers included):	1380g
Max Ascent / Descent Speed:	6m/s / 4m/s
Max. flight speed:	20m/s
Max. flight time:	28 min.
Camera	
Operating Environment Temperature:	0°C-40°C
Sensor size:	1/2.3"
Effective Pixels:	12 Megapixels
Resolution:	4000×3000
Gimbal pitch	-90° to +30°
Remote Control	
Communication Distance (open area):	CE Compliant: 3,5km; FCC Compliant: 5km

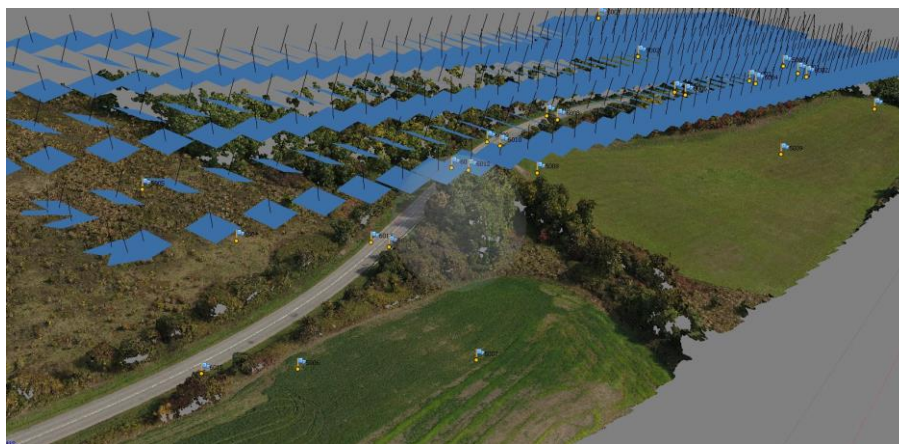
Fig. 5. Image processing in Agisoft PhotoScan® with positions of images.
Source: Own study.

The aerial images were graphically modified before processing in specialised photogrammetric software. The adjustment consisted of the following features: white balance correction, Noise reduction, and Chromatic aberration correction. Subsequently, the images were processed in the Agisoft PhotoScan® software (Fig. 5). Agisoft PhotoScan® is photogrammetric software for efficient 3D image processing to

In final 344 images were processed in our research. A total of 10 ground control points (GCP) (Fig. 5 and 6) were used to transform the frame into the S-JTSK coordinate system. The GNSS Leica 900CS gave
